HISTORY

CASE

The critical pipe line rehabilitation at Westwood Lakes

Extraordinary
Properties make
CoREZYN®
Vinyl Ester
“Resin of Choice”

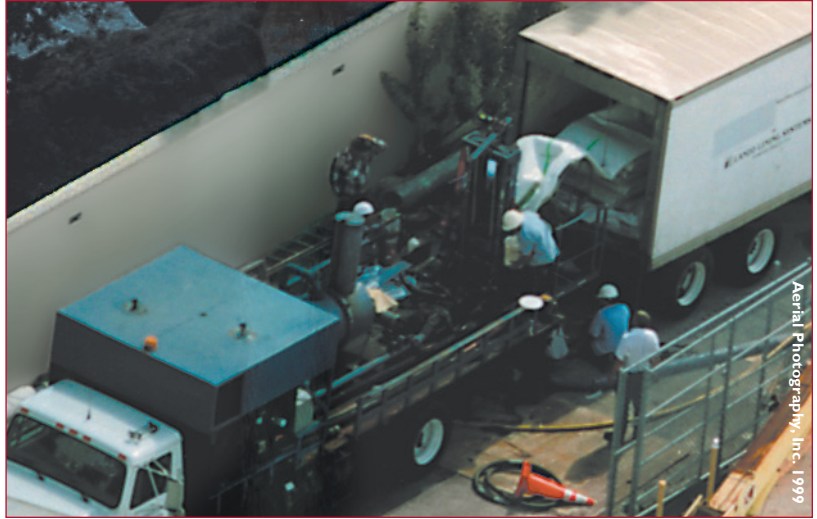
The project consumed 10,670 pounds of vinyl ester resin.

Prior to the tube's arrival at the job site, an inversion column was set up. Due to the tube's large diameter, a thrust block was used in the sending manhole to counter inversion forces during early installation stages. A day before the installation, CoREZYN vinyl ester resin was catalyzed and pumped into the tube, which was carried along on a conveyor and carefully monitored to ensure uniform wall thickness. Because of the number and size of the defects plus the aggressive influent water into the pipe, an additional 5% sacrificial resin was used to prevent washout or contamination of the 19.5 mm finished design thickness. The project consumed 10,670 pounds of vinyl ester resin.

The wetted-out tube was loaded into a refrigerated vehicle and transported to the job site during the night to avoid possible traffic delays and the heat of the Miami sun. When the 11,000-pound tube arrived, an on-site water source was used to inflate the tube during the inversion process. Once inflated, the tube's internal water temperature was ramped slowly to 140oF (the curing threshold) and maintained for an hour, allowing the line to stabilize. This also allowed the resin to saturate the existing

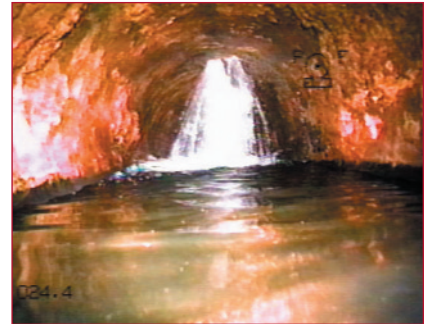
Pipe Before

With the bypass in place, the existing line was cleaned while Lanzo's crew conducted a closed-circuit video inspection to reveal the nature and location of the pipeline defects. The video data identified several major leaks. Hydrogen sulfide attack on the crown of the pipe was compounded by the scouring action of high velocity flows.

"The cast iron pipe also had major scaling and oxidation byproduct deposits which needed to be removed, giving us a smooth, symmetrical surface for the new liner," said Tingberg. The cleaned pipe's effective diameter was 32-inches instead of the 30-inch standard that Lanzo anticipated. "We had a 30-day window to complete the job, so we rush-ordered a special tube to be air-freighted to our Pompano Beach (FL) plant. There it was fitted with turn ropes and further customized to meet the host pipe's geometry."

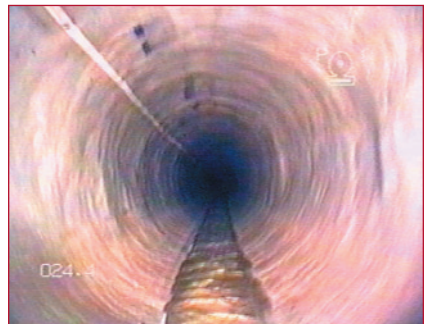
Pipe After

defects in the host pipe. Then the temperature was increased to 180°F and maintained for the balance of the cure cycle. After that, Lanzo's crew reinstated pipe ends and laterals and post-televised the line. Samples were drawn and sent to an independent testing laboratory to document the flexural strength and modulus achieved in the field. Additionally, this information proves the quality of the wet-out and completeness of the cure. It also validates the design basis for the selection of the wall thickness. The rehabilitated pipe has a 50-year life expectancy.
