INBODE uses Trenchless Rehabilitation to Limit Negative Social Impact on Mexico City's Largest Renovation of Deteriorated Sewer Lines

Interplastic's CoREZYN® products used for Cured-in-Place-Pipe method

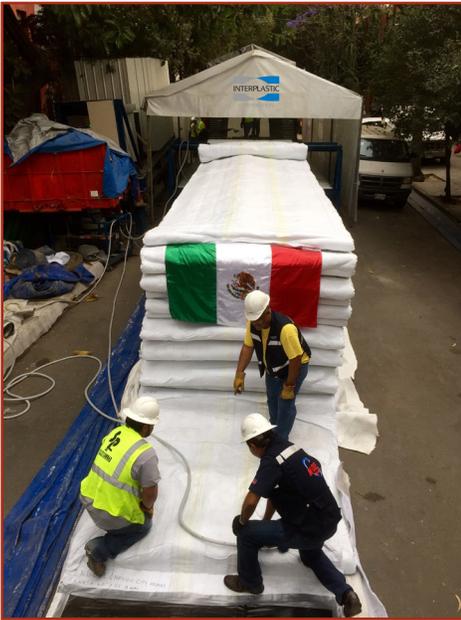
810 foot long felt tube

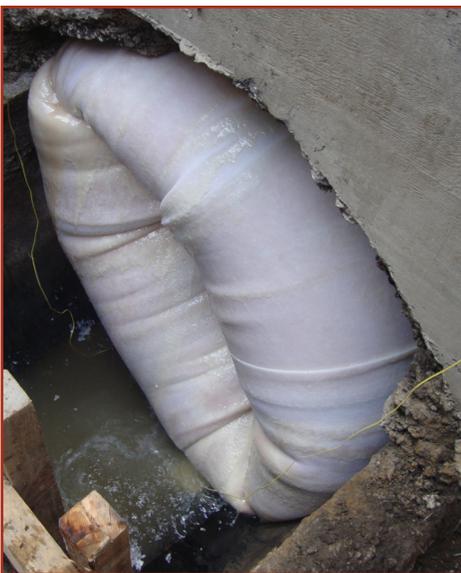
Inverted tube fed into host pipe

Solution: The line was a gravity line under an existing roadway with manhole access making CIPP an ideal choice. The resin used was a premium, corrosion resistant, enhanced, CIPP resin designed by Interplastic Corporation. “Interplastic’s resin is the best option on the market for our customer. The consistency in the quality batch to batch and the great service we receive was why we went with Interplastic Corporation resin”, said Daniel Posadas, INBODE’s Director. Since the project required long lengths of large diameter liner, INBODE determined their equipment designed for Over-the-Hole (OTH) inversions would work best. The set-up included a conveyor belt system, on which the felt tube would be saturated with resin; a static mixer, to mix the resin system components and accurately dispense this system; bypass pumps, to permit flow of wastes from upstream of the project site; a large bulk storage tank to hold the resin; and various pieces of equipment for cleaning, CCTVing and heating and pumping the process water. Due to the lack of fire hydrants in that street, water for inversion and curing of the liner had to be brought in tankers. The felt tube was laid on the conveyor. This tube was 60 inches in diameter, 22.5 mm thick and about 247 meters long (810.4 ft). Resin that had run through the static mixer to incorporate the appropriate amount of initiator was metered into the dry tube. The wet out tube was inverted and fed into the host pipe as each section was wet out. The inversion was facilitated with pressure from a head of cold water. Once the liner was completely inverted the water used to invert the liner was heated to a water temperature of about 180°F (82°C). The water was kept at that temperature until the liner was cured. The water was then slowly cooled until it reach below 100°F (38°C). Once cured, the ends were cut out and services restored over a period of time.

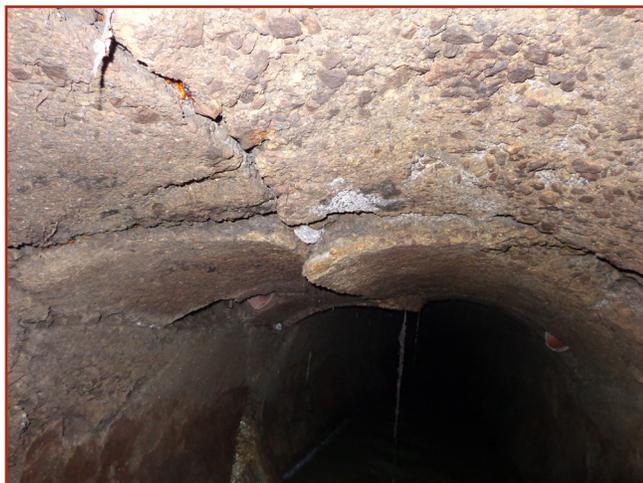
The lines that required renovation were concrete pipes over 90 years old. They had deteriorated due to age, traffic loading, and corrosion from sewer gases in the line. The earthquake of 1985 also significantly damaged the concrete pipes. Sections of the existing pipe had cracked and some pieces had separated. Sand, dirt, and non-wastewater infiltration were all entering the existing pipe through cracks and broken or missing sections of pipe. These issues, along with the rough pipe surface, all impeded the flow of the pipe causing capacity issues.

Before Rehabilitation

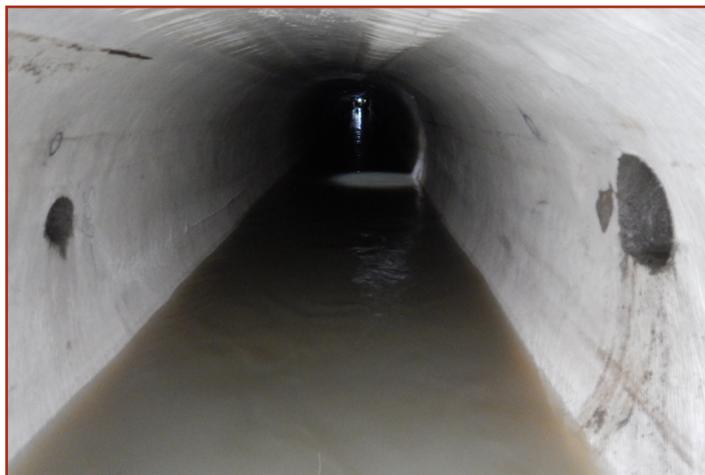
After Rehabilitation

The entire process of wetting out the tube, inverting the liner, cooking and curing the liner, and restoring service took about 72 hours. The new liner had a slightly smaller cross section than the existing host pipe, but the smoother surface of the new liner provided a higher flow capacity than the old pipe. This was the first project of this size attempted by INBODE and they have proven the worth. This new pipe within a pipe is projected to last a minimum of 50 years and based on historical assessments on current CIPP liners likely much longer.
